## Common Defects

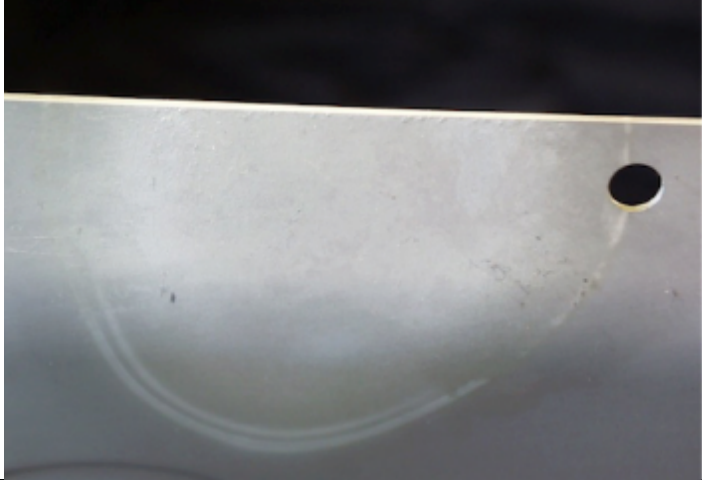
| Defect | <b>Anodizing Burn</b> | |

| Description | <ul style="list-style-type: none"> <li>Bright areas on anodic coating surrounded by black or darker area.</li> <li>Usually no anodic film or very soft film present in the defective area.</li> </ul> | |
| Cause | <ul style="list-style-type: none"> <li>Excessive current</li> <li>Poor movement of electrolyte across part</li> <li>Poor electrical contact between rack/jig and the part.</li> </ul> | |
| Remedy | <ul style="list-style-type: none"> <li>Reduce current</li> <li>Check electrolyte concentration and ensure temperature is controlled properly</li> <li>Improve electrical contact area between rack/jig and the part</li> </ul> | |

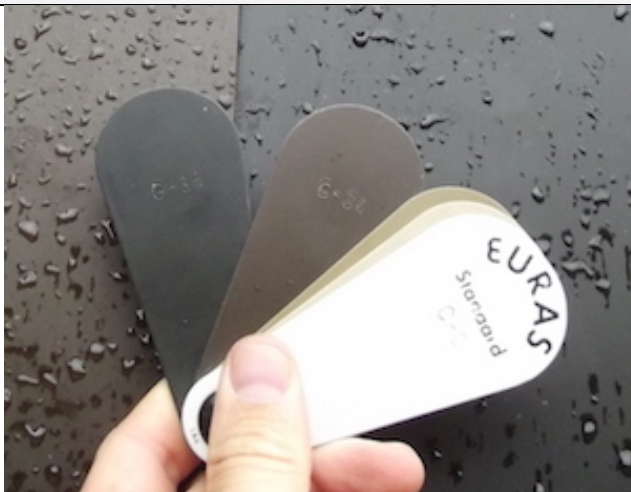
| Defect | Color Differences | |
|---|---|--|
| Description | Poor visual color match, outside the agreed upper and lower color limits. | |
| Cause | <ul style="list-style-type: none"> <li>• Alloy inconsistency</li> <li>• Differences in the anodizing parameter</li> <li>• Incorrect dyeing conditions</li> <li>• Lack of control of electrolytic coloring process</li> </ul> | |
| Remedy | <ul style="list-style-type: none"> <li>• Make sure the base metals are from the same batch.</li> <li>• Check anodizing electrolyte concentration, PH, anodizing time and temperature</li> <li>• Check dye concentration, dye time, temperature, PH and for contamination with sulphates and chlorides.</li> <li>• In the case of electrolytic coloring, this can be due to the wrong coloring condition or contamination of the coloring electrolyte with sodium. Fix racking configuration to ensure color uniformity</li> </ul> | |

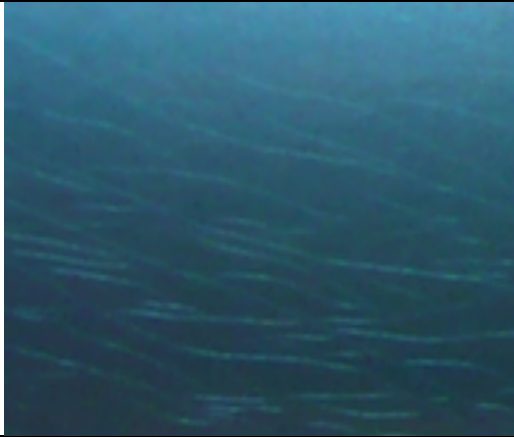
| Description | Hairline cracks form in the anodic coating. | |
| Cause | <ul style="list-style-type: none"> <li>Stress produced in the anodic oxide coating when parts are transferred from rinse tank to sealing tank due to differences in thermal expansion coefficient between the anodic oxide coating and the base metal.</li> <li>Caused by a mechanical deformation of an anodized part by bending or impact. Can be enhanced by high current, low electrolyte temp, thick anodic films (hard anodizing conditions).</li> <li>Anodic oxide coatings exposed to high ambient temperatures (e.g. lighting) and strong sunlight are more likely to develop crazing than those exposed in the more temperate climates</li> </ul> | |
| Remedy | <ul style="list-style-type: none"> <li>Reduce thermal shock (70°C water before boiling sealing)</li> <li>Any bending of the parts should be carried out before anodizing. Pre heat parts to even out stress in material (130°C for 40min). Reduce current (1.4-1.6 A/dm<sup>2</sup>). Electrolyte temperature should be around 20°C. Reduce anodic film thickness (&lt;30µm)</li> </ul> <p>Don't heat thick film above 120°C</p> | |

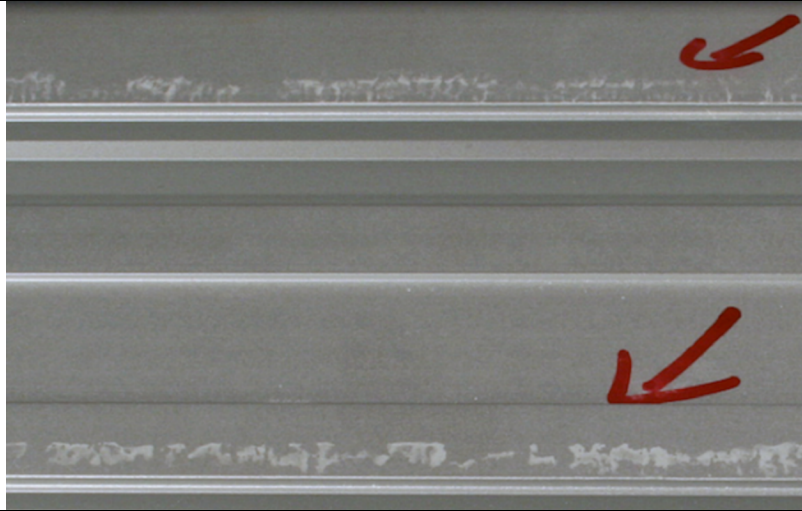
| Defect | Etch Staining | |
|---|---|--|
| Description | Staining develops on the part after etching. This may not be immediately visible after etching. | |
| Cause | <ul style="list-style-type: none"> <li>• Etching solution dries on part during transfer to rinse</li> <li>• Poor cleaning/rinsing after etching.</li> <li>• Poor jigging in combination with poor cleaning</li> <li>• Wrong etch solution composition</li> <li>• Etch solution too hot</li> </ul> | |
| Remedy | <ul style="list-style-type: none"> <li>• Improve time from etching to rinse</li> <li>• Ensure good and fast cleaning/rinsing after etching.</li> <li>• Proper jigging of difficult or thick walled profiled parts</li> <li>• Check the level of wetting agent in the etching solution is adequate</li> <li>• Ensure etch solution temperature isn't too high (&lt;60°C)</li> </ul> | |

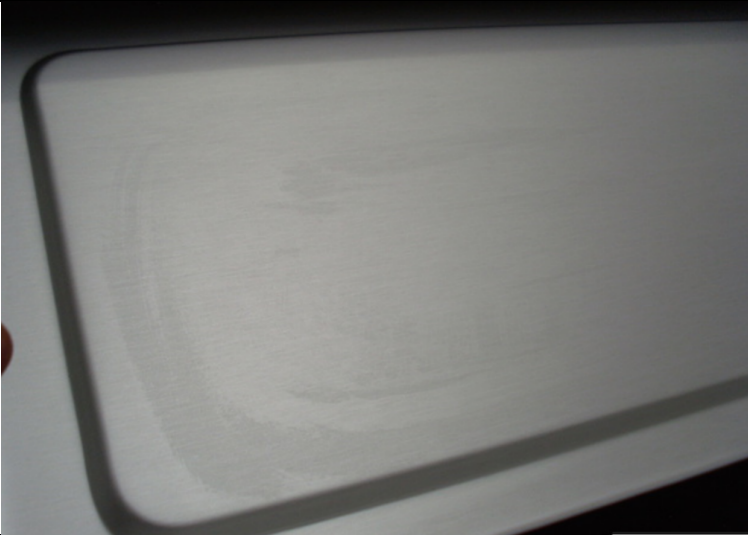
| Defect | Insufficient Degreasing | |

| Defect | Insufficient Degreasing | |
|---|---|--|
| Description | Non uniform Degreasing | |
| Cause | Poor degrease solution or practice (e.g. temperature too low), oil or grease is still left on some areas. This leads to differential etching/ brightening of the section surface | |
| Remedy | Renew the degreasing solution or extent the treatment time or increase the temperature. | |

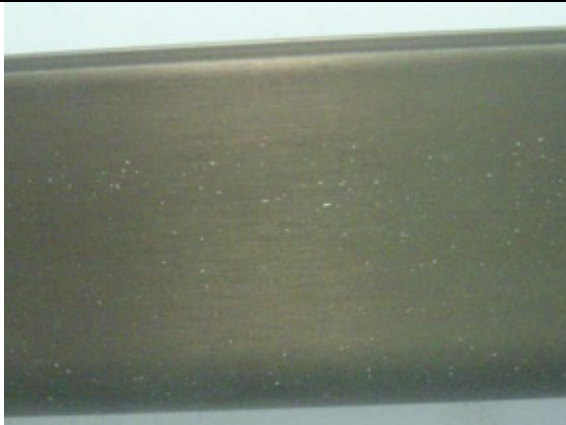
| Defect | White Spots |
|---|---|
| Description | Little white spots develop in the anodized layer after electrolytic or dye coloration. |
| Cause | <ul style="list-style-type: none"> <li>• <u>White spot that can't be wiped off, and in round shape</u> <ul style="list-style-type: none"> <li>- Likely due to the surface contamination that is result of residue that was not adequately removed by anodizer that inhibit dye from picking up. Another may be the presence of alkaline particles floating around in the air and adhering to the anodize surface while being transferred to the dye tank.</li> </ul> </li> <li>• <u>White spot that can't be wiped off, and not in round shape</u> <ul style="list-style-type: none"> <li>- Usually the result of entrapped anodize acid in tiny pits, cavities or groves. Pits may be due to unwanted iron-containing inclusions in the metal that are etched out during the anodize step. Cavities may be due to the porosity of cast aluminum. Tiny groves may occur on machined surfaces. Anodizing can open up surface or near-surface defects, leaving voids that can be very difficult to rinse clean. As a result, dye pickup will be inhibited in the area where any acid remains. Usually the acid oozes out of the pit or cavity while in the dye tank, forming irregular shaped spots, including comet tails.</li> </ul> </li> </ul> |
